# Test Report

Report No. : RGST250623710

**Applicant** : Particle Industries, Inc.  
**Address** : Rm2006, 20/F, Blk A, Coast Building E Twr Haide 3Rd, Nanshan Dist, SZ, China  
**Sample(s) Name** : M1ENCLEA  
**Model Name** : M1ENCLEA  
**Sample(s) received date** : June 23, 2025  
**Testing period** : From June 23, 2025 to June 25, 2025

- (1) As specified by client, to do the IP6X Dust Test on the submitted sample(s).  
(2) As specified by client, to do the IPX7 Water Resistance Test on the submitted sample(s).

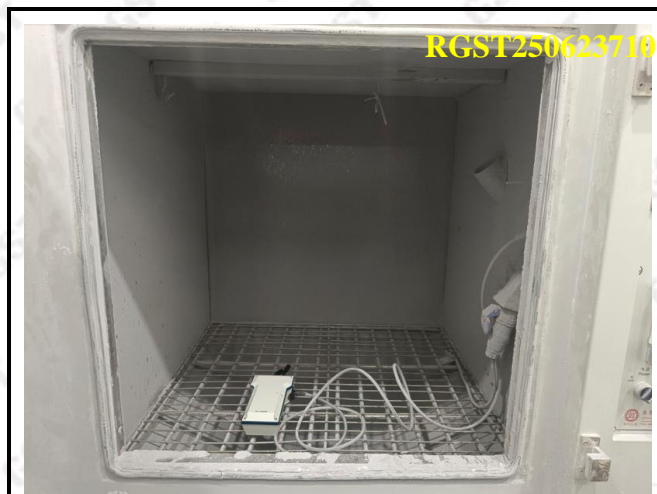
Test Condition: 1) Detect the gap portion of the sample with a test probe of  $\phi 1$  mm. The test force is 1 N;  
2) Placing the sample in a test chamber containing 2 kg of talc per cubic meter;  
3) Test time: 8 h

Fig 3 During the test

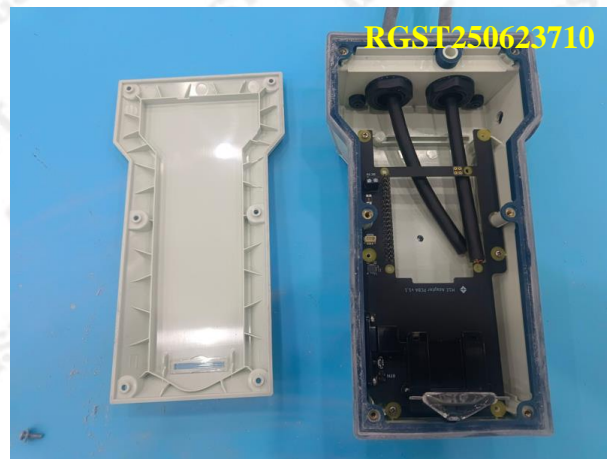
Sample Name	Sample No.	Test Result(s)	Verdict
M1ENCLEA	001	After the test, no dust was found in the sample.	Pass

Fig 4 After the test

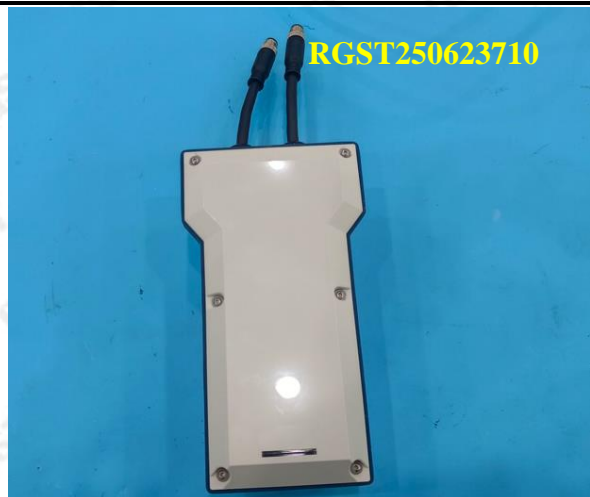
Fig 5 Before the test

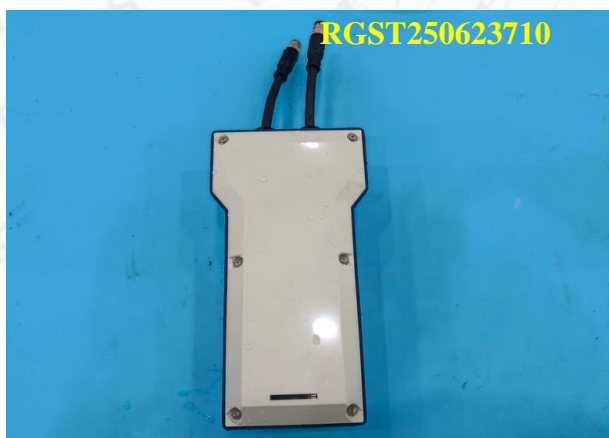
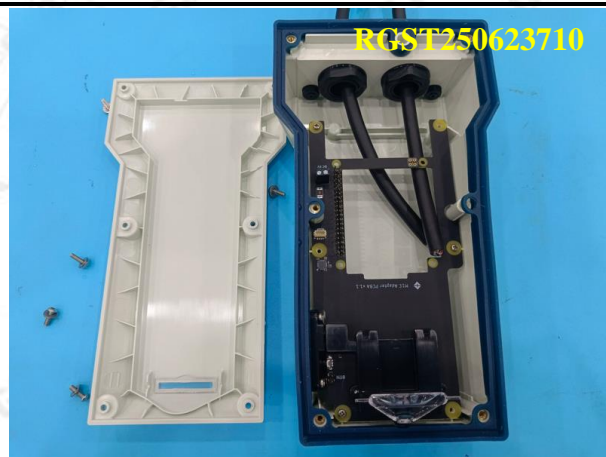
Sample Name	Sample No.	Test Result(s)	Verdict
MIENCLEA	001	After the test, no water was found in the sample.	Pass

Fig 7 After the test

Fig 8 After the test
